OLD RADIO REPAIRS

Old Radio Repairs Web Site

A Zenith 5S228, from 1937

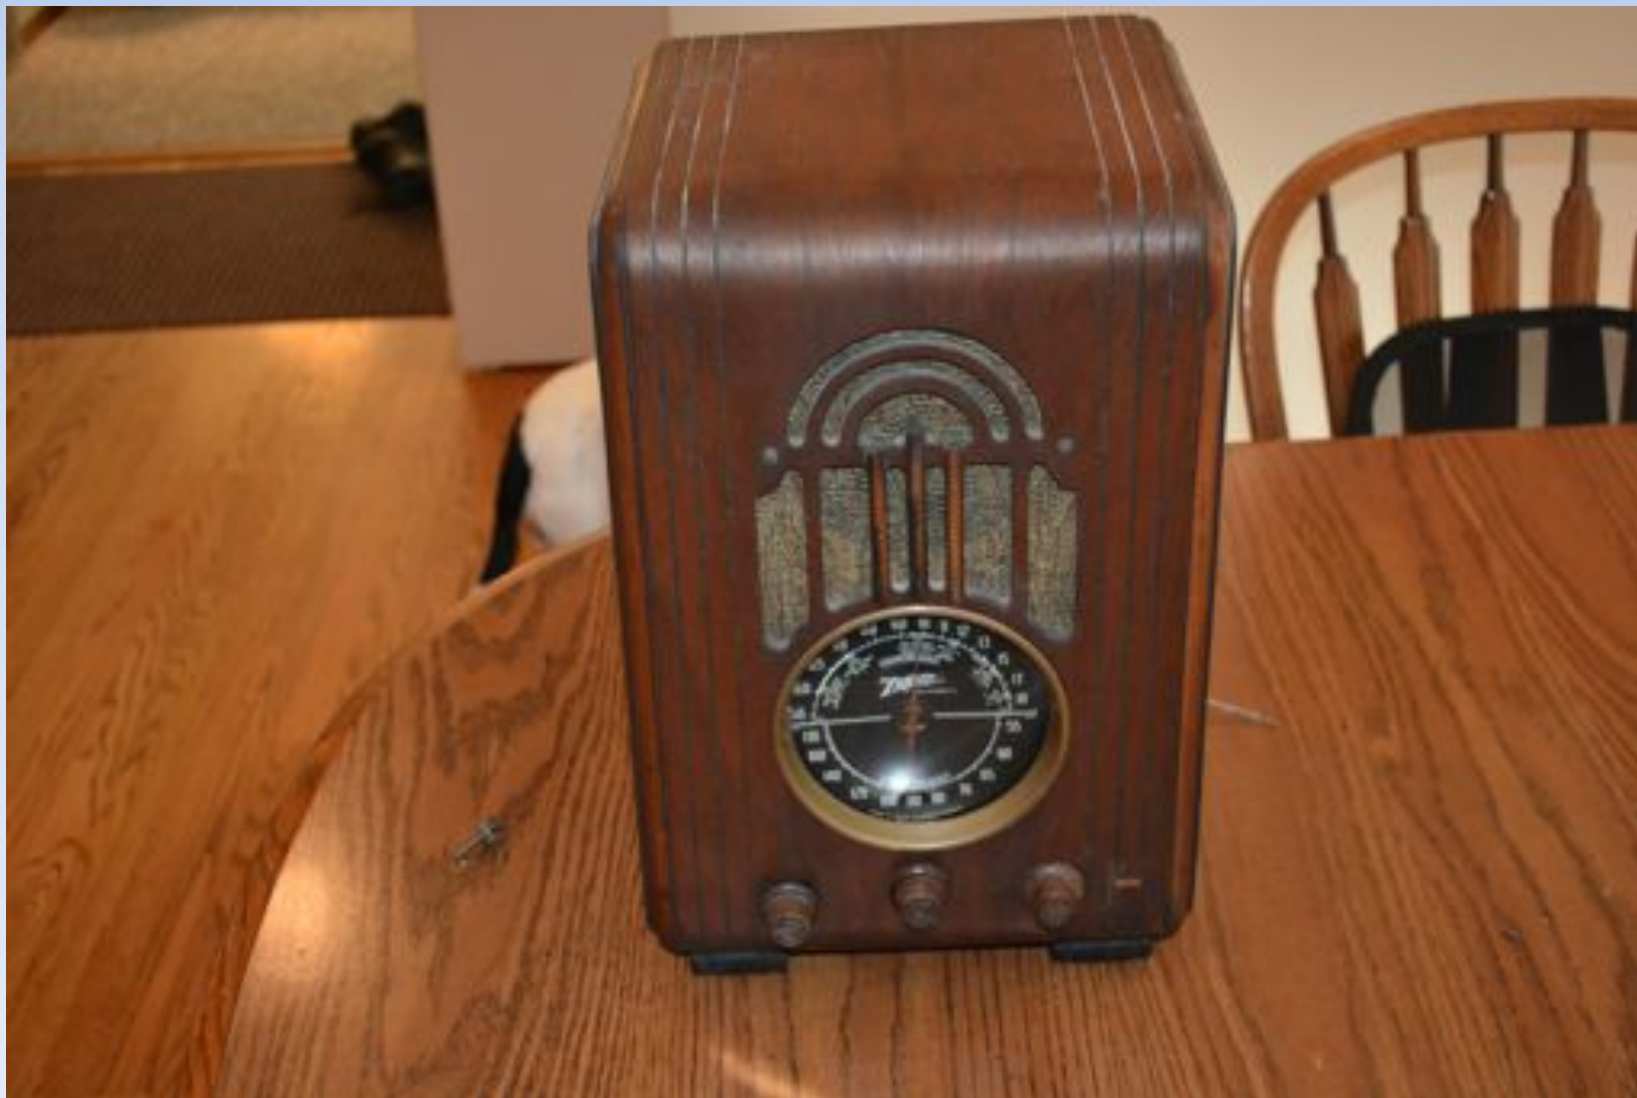
Radio Chassis Removed

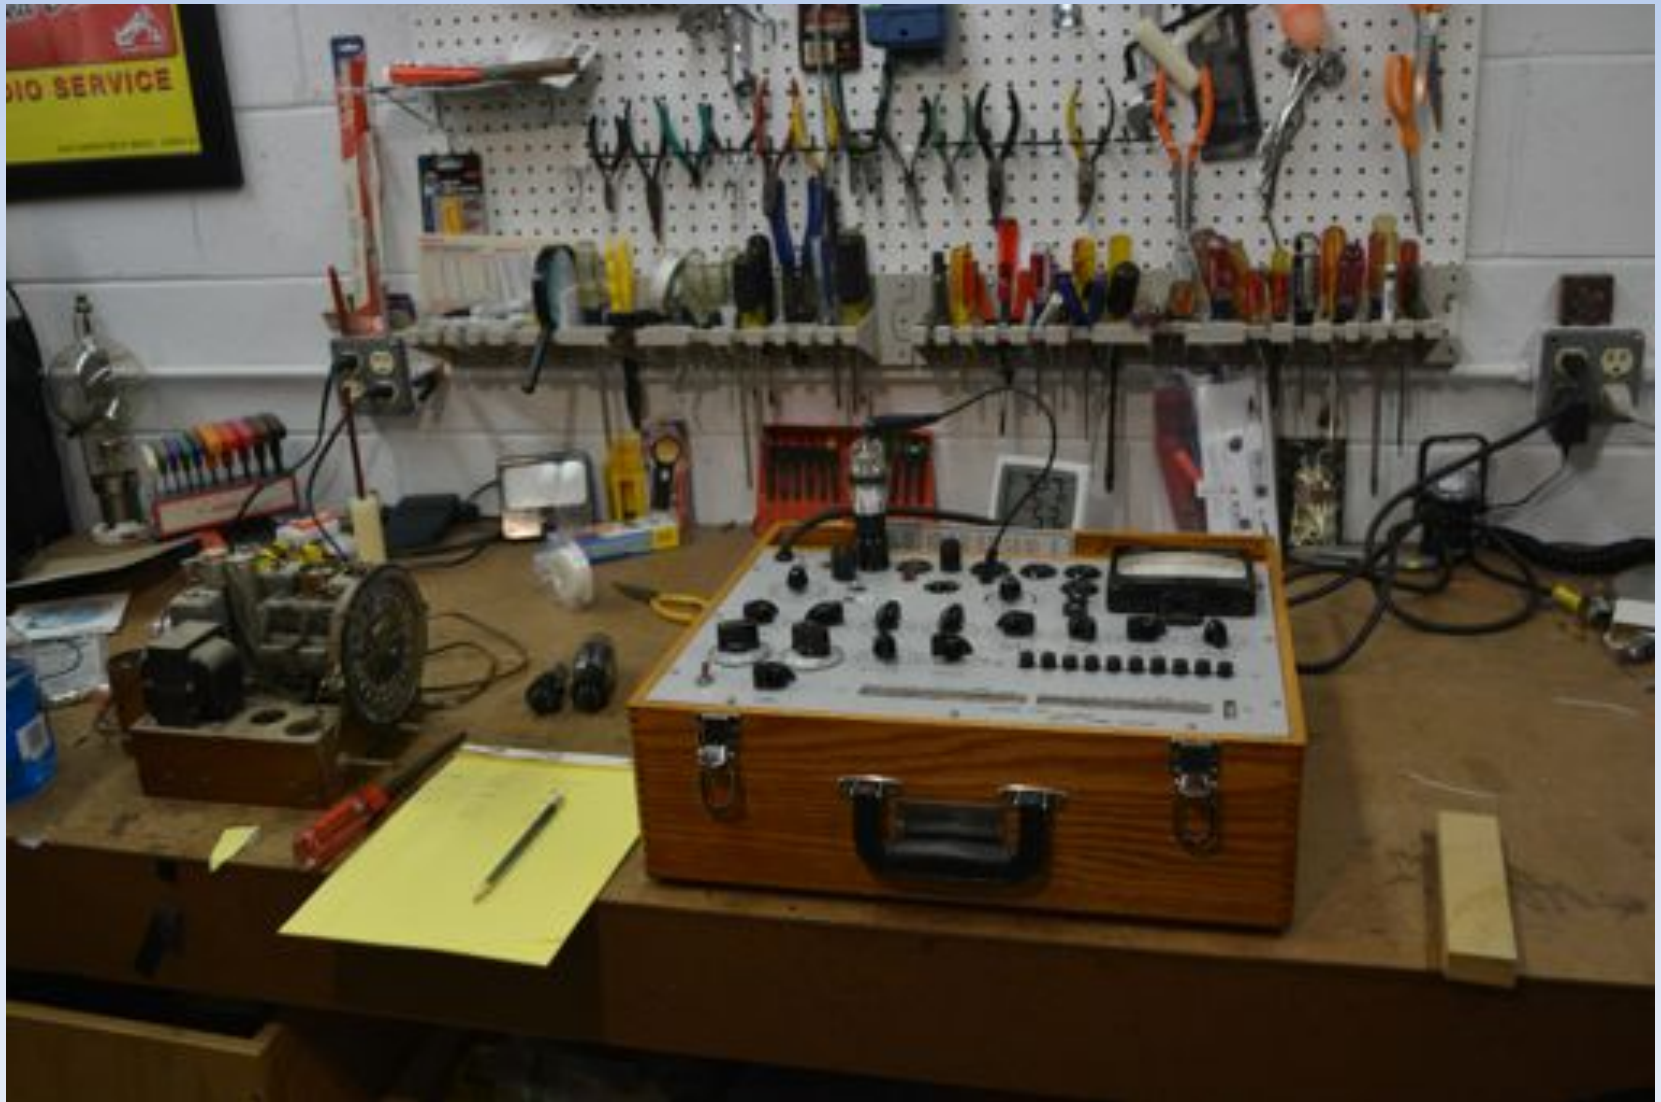
Test Equipment Used

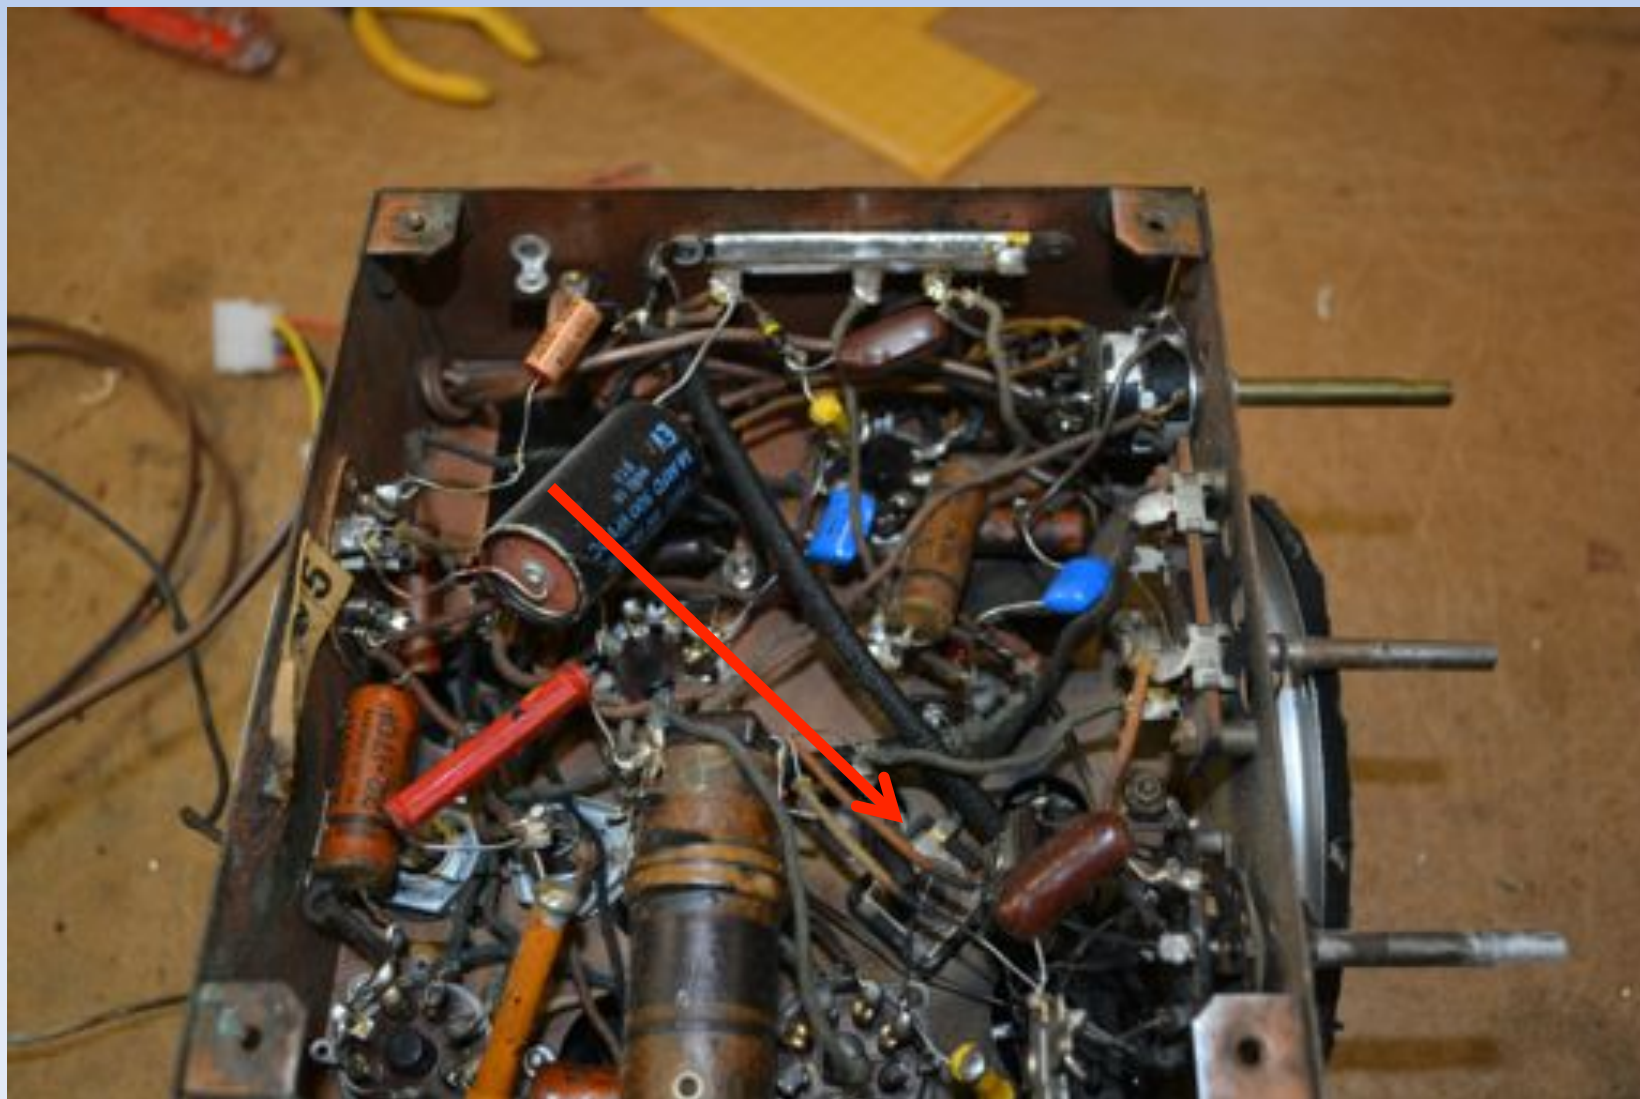
Surprise , many burnt wires

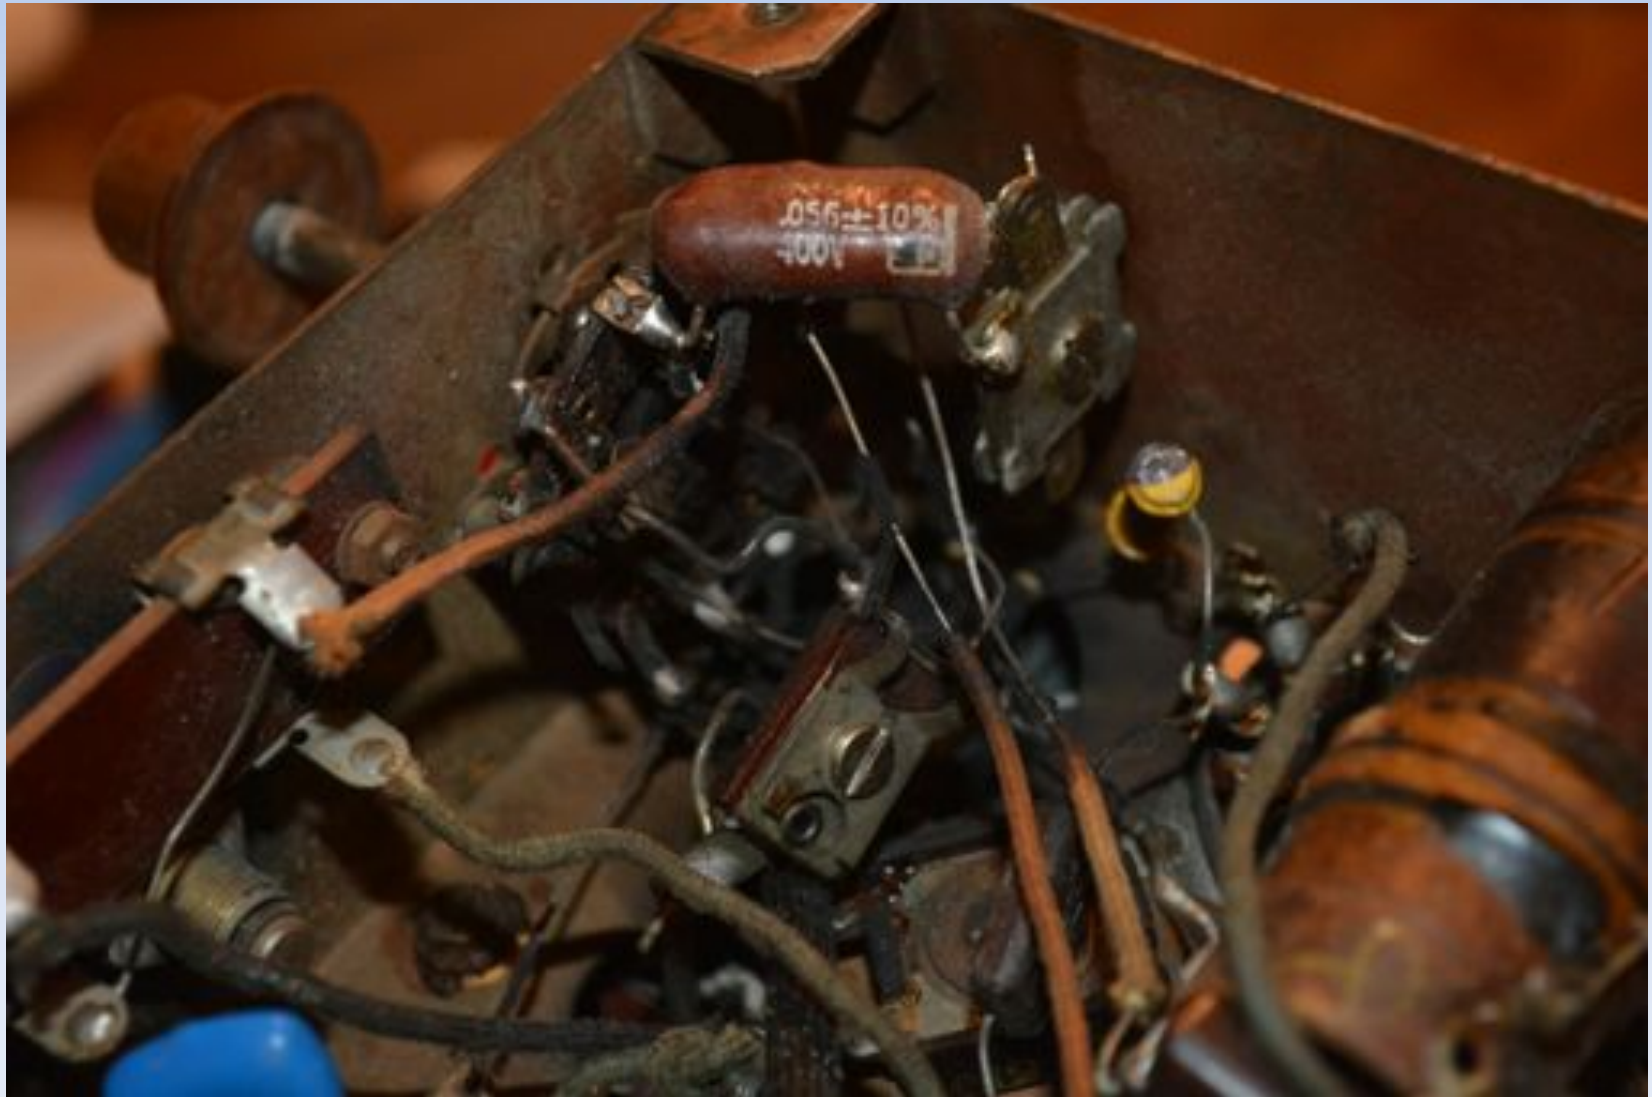
Burnt wires close-up

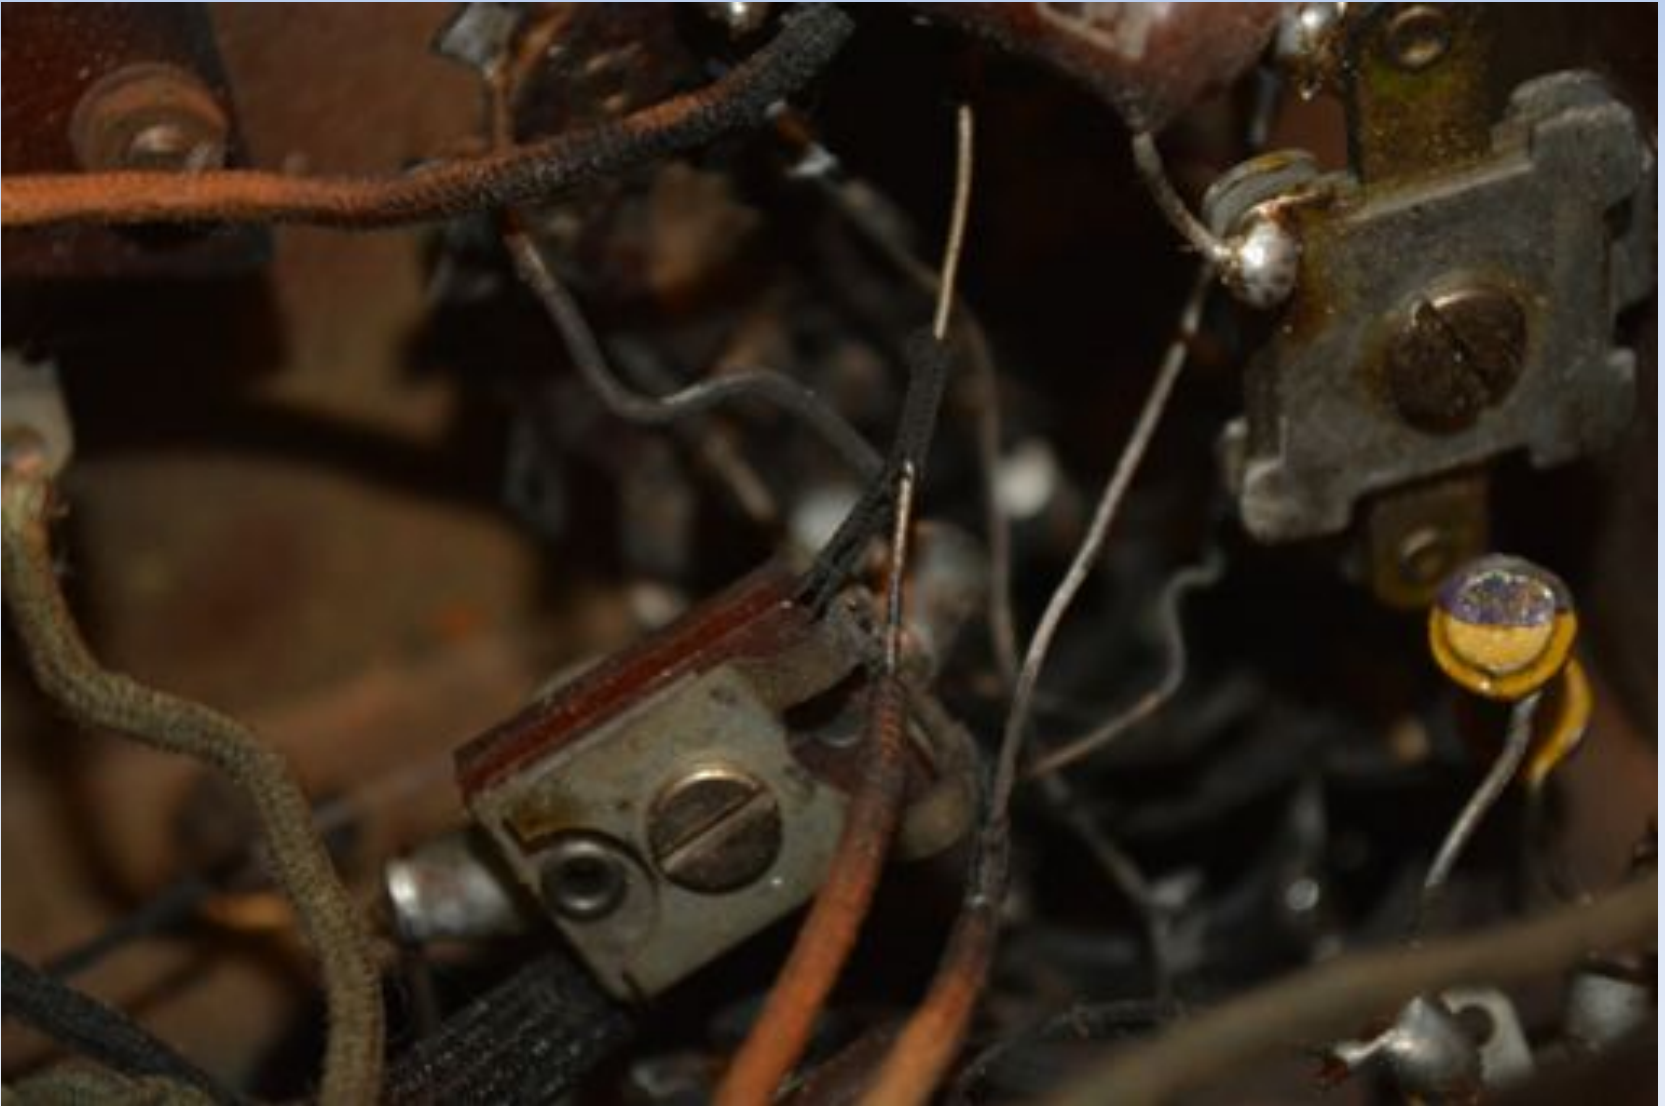
Damaged Band Selector Switch

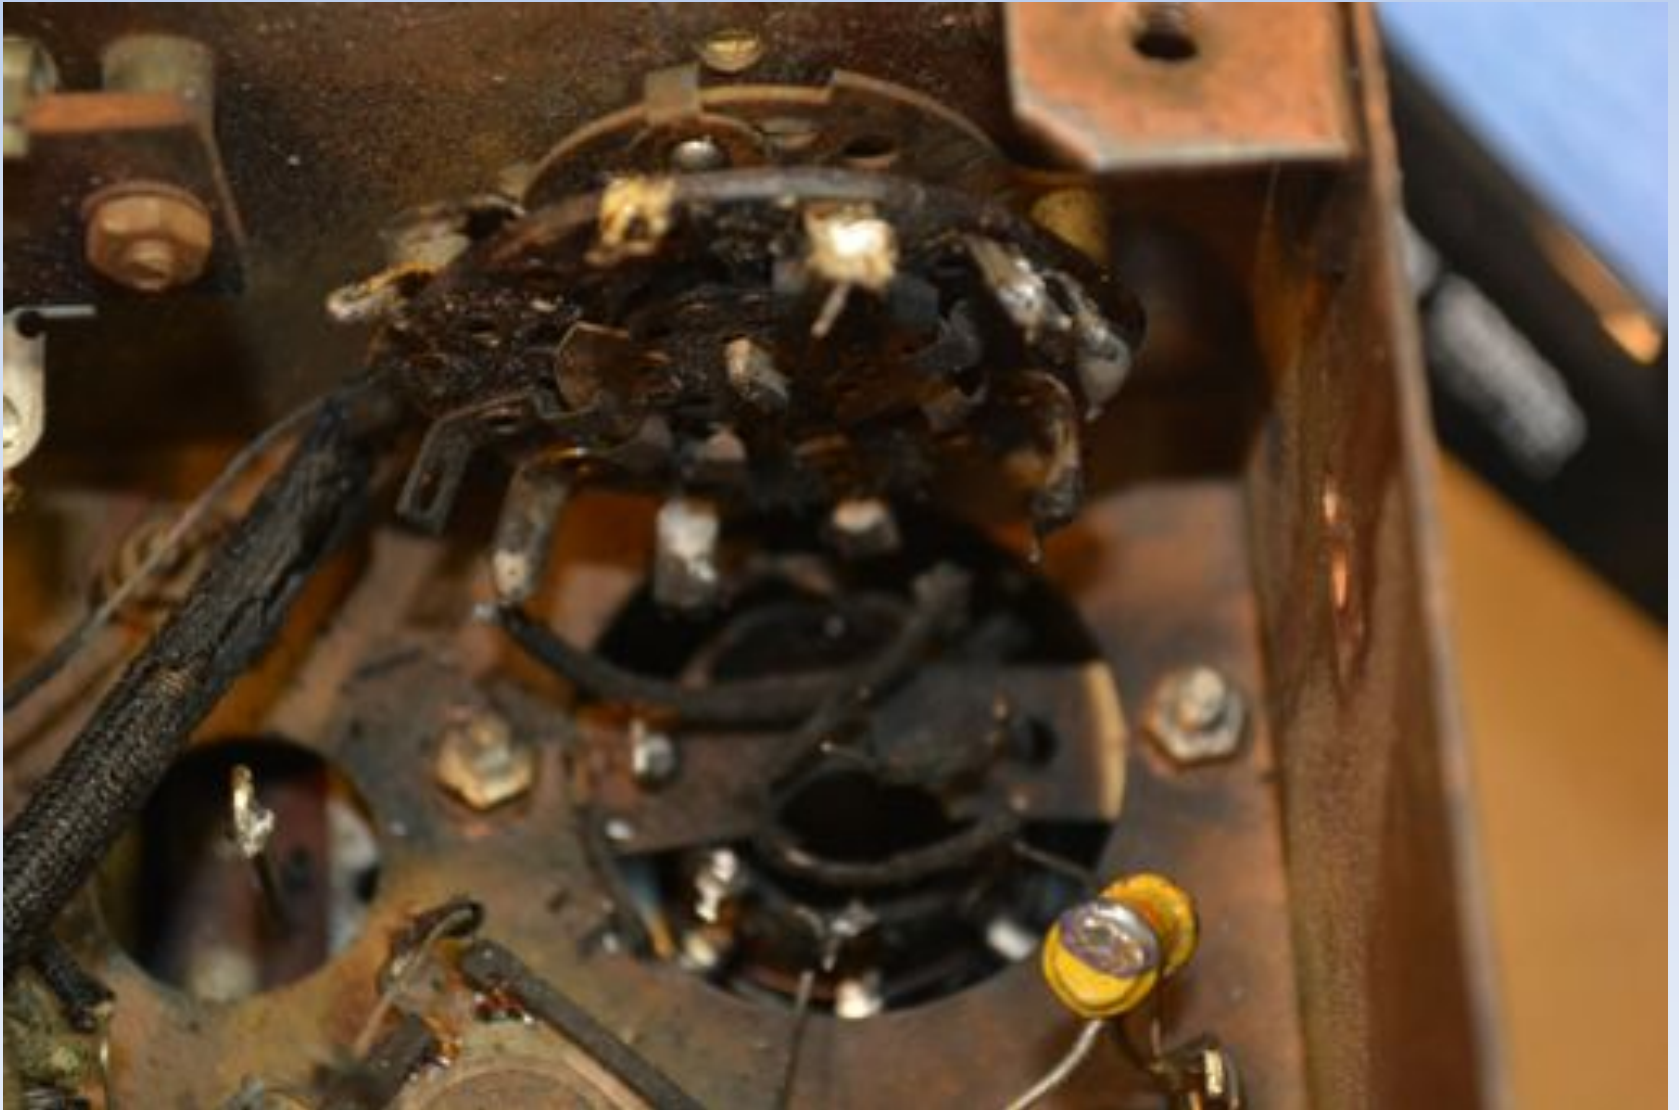
Input Coil Set Removed

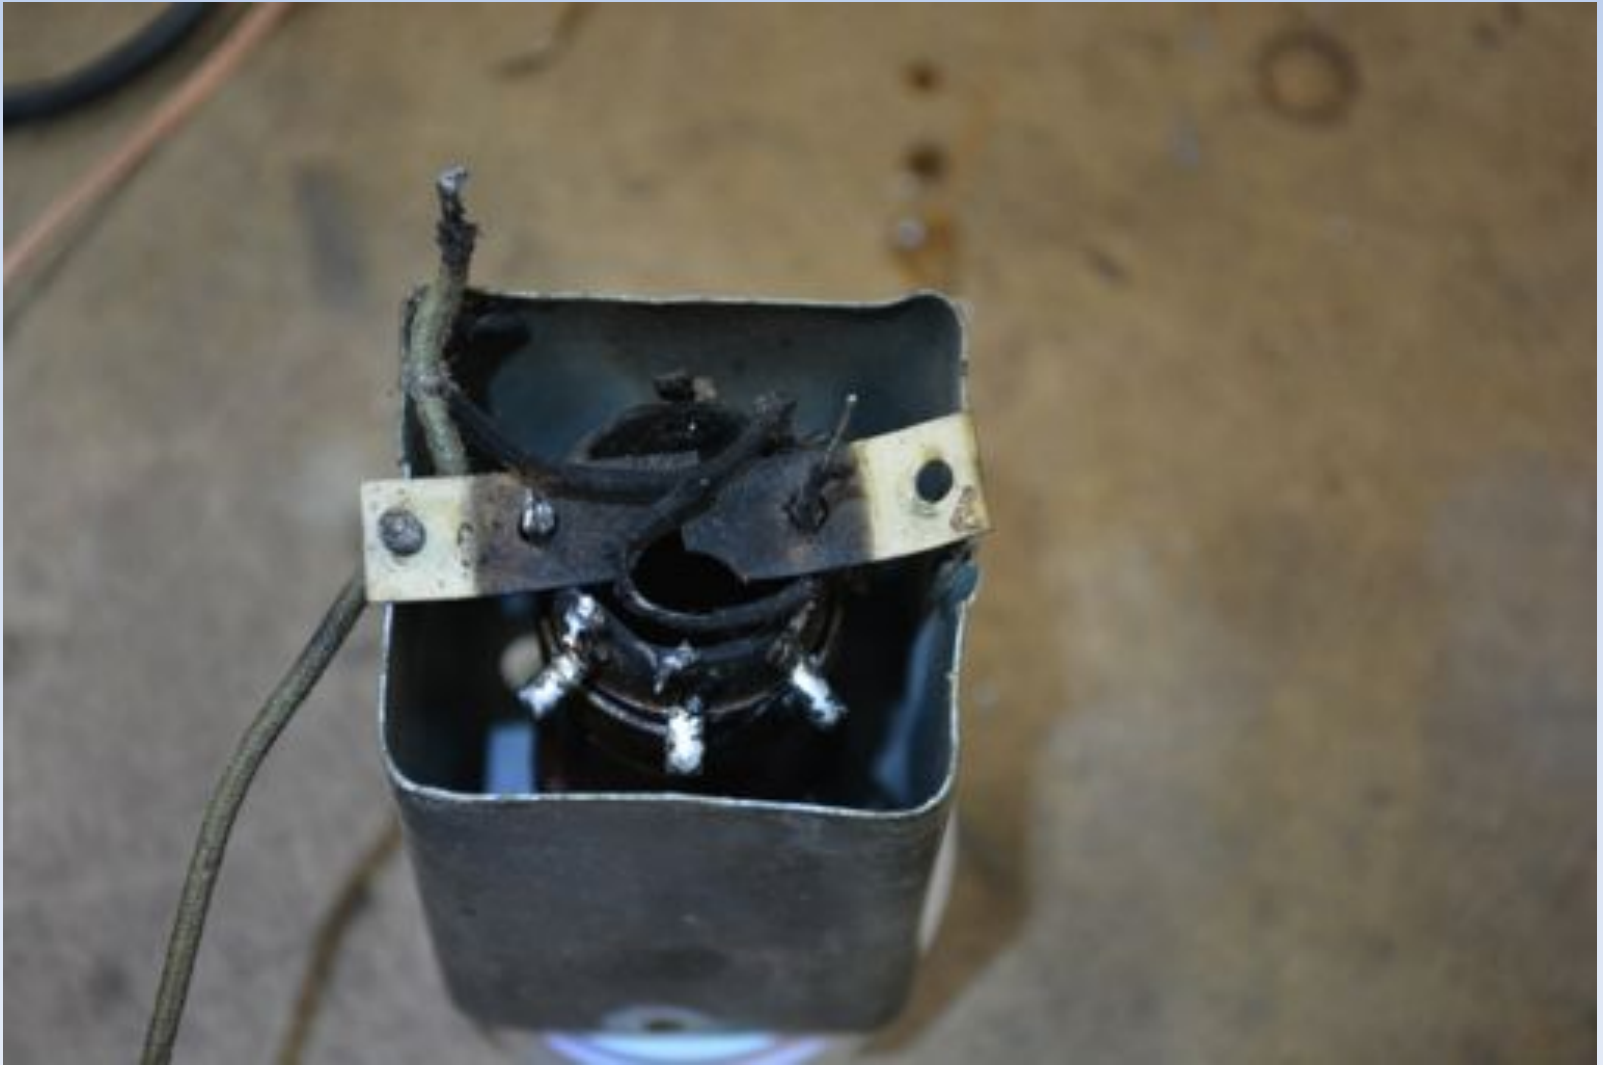
Coil Set Removed from Can

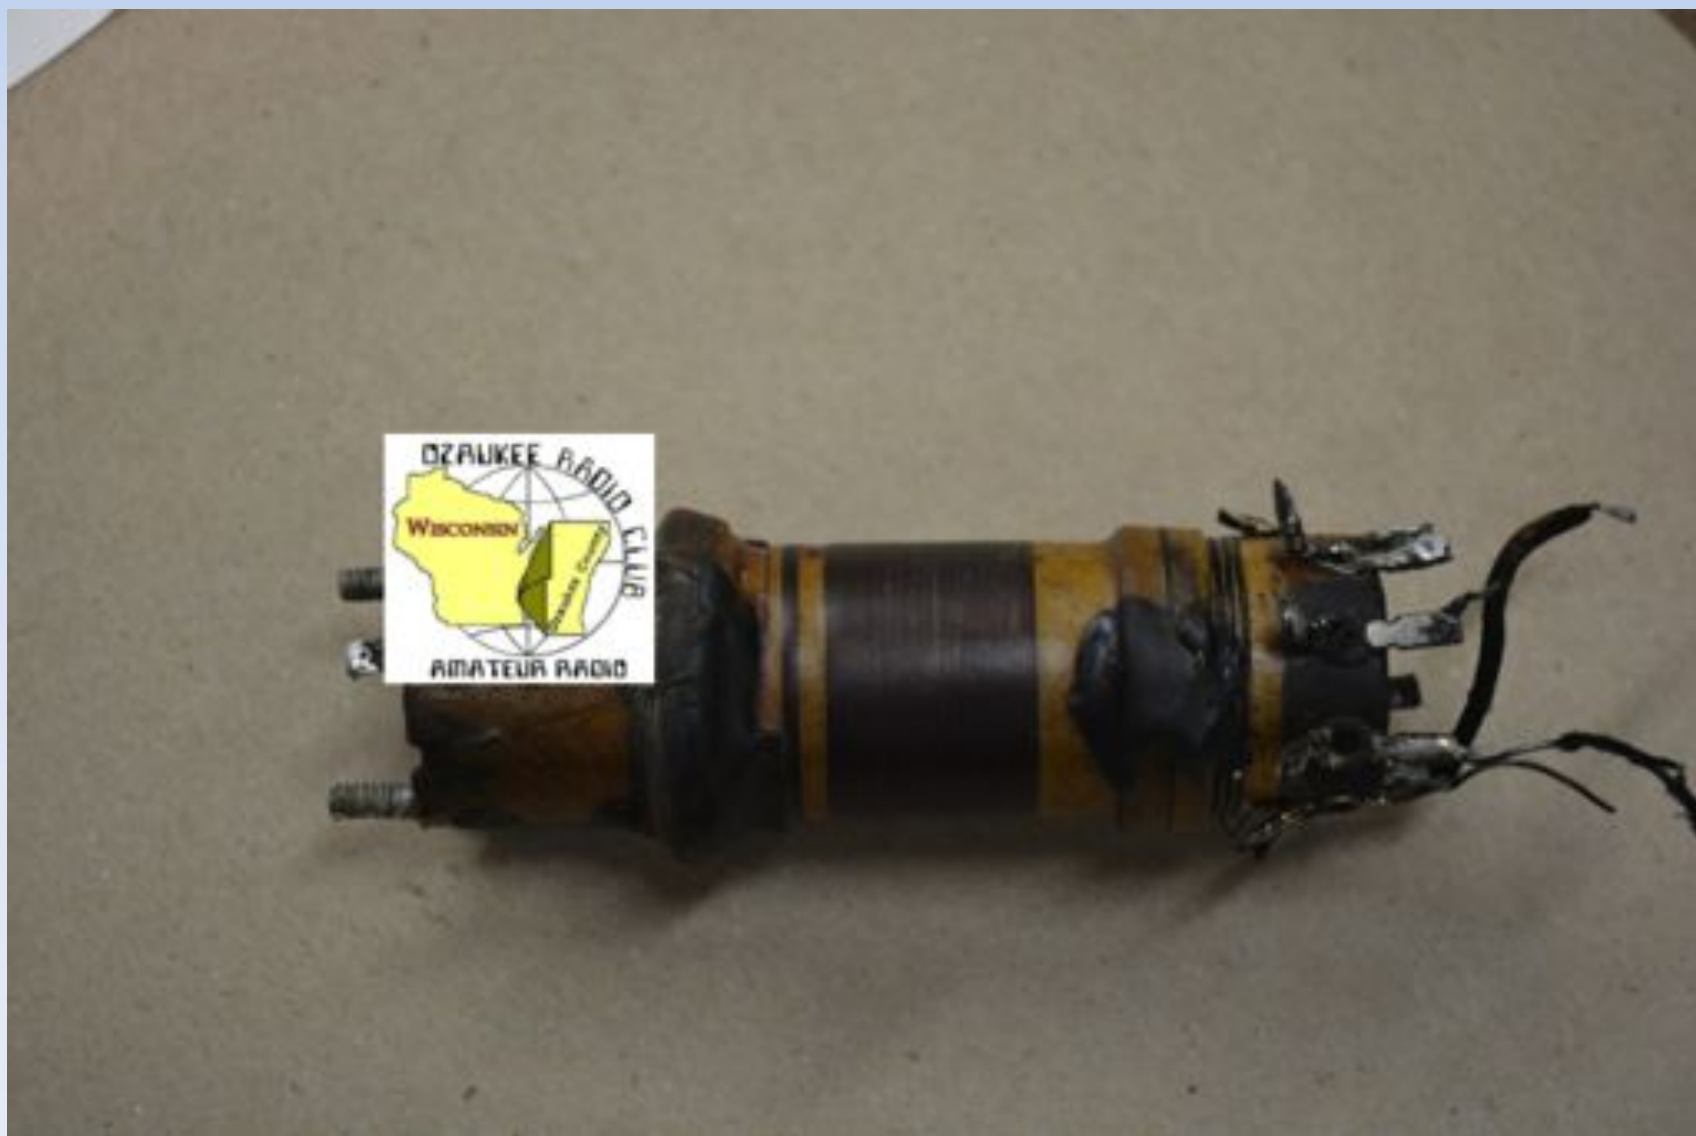
None of the individual coils were open!

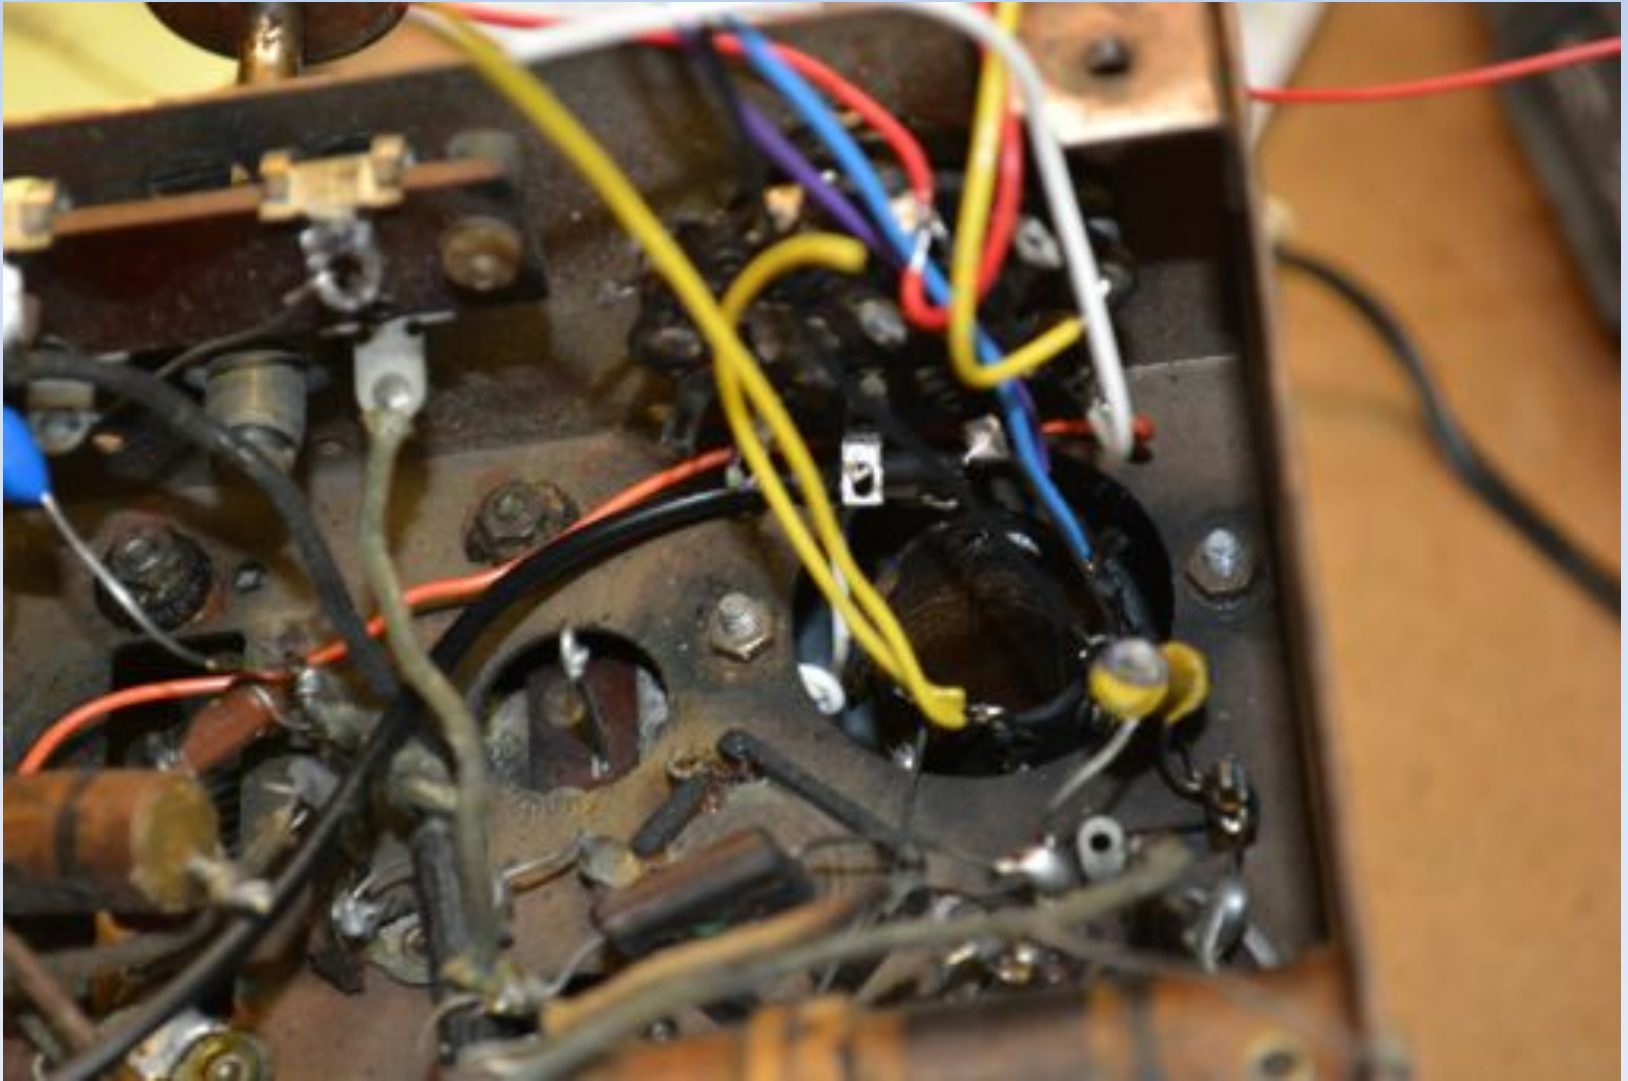
Arcing Tube Socket Replacement

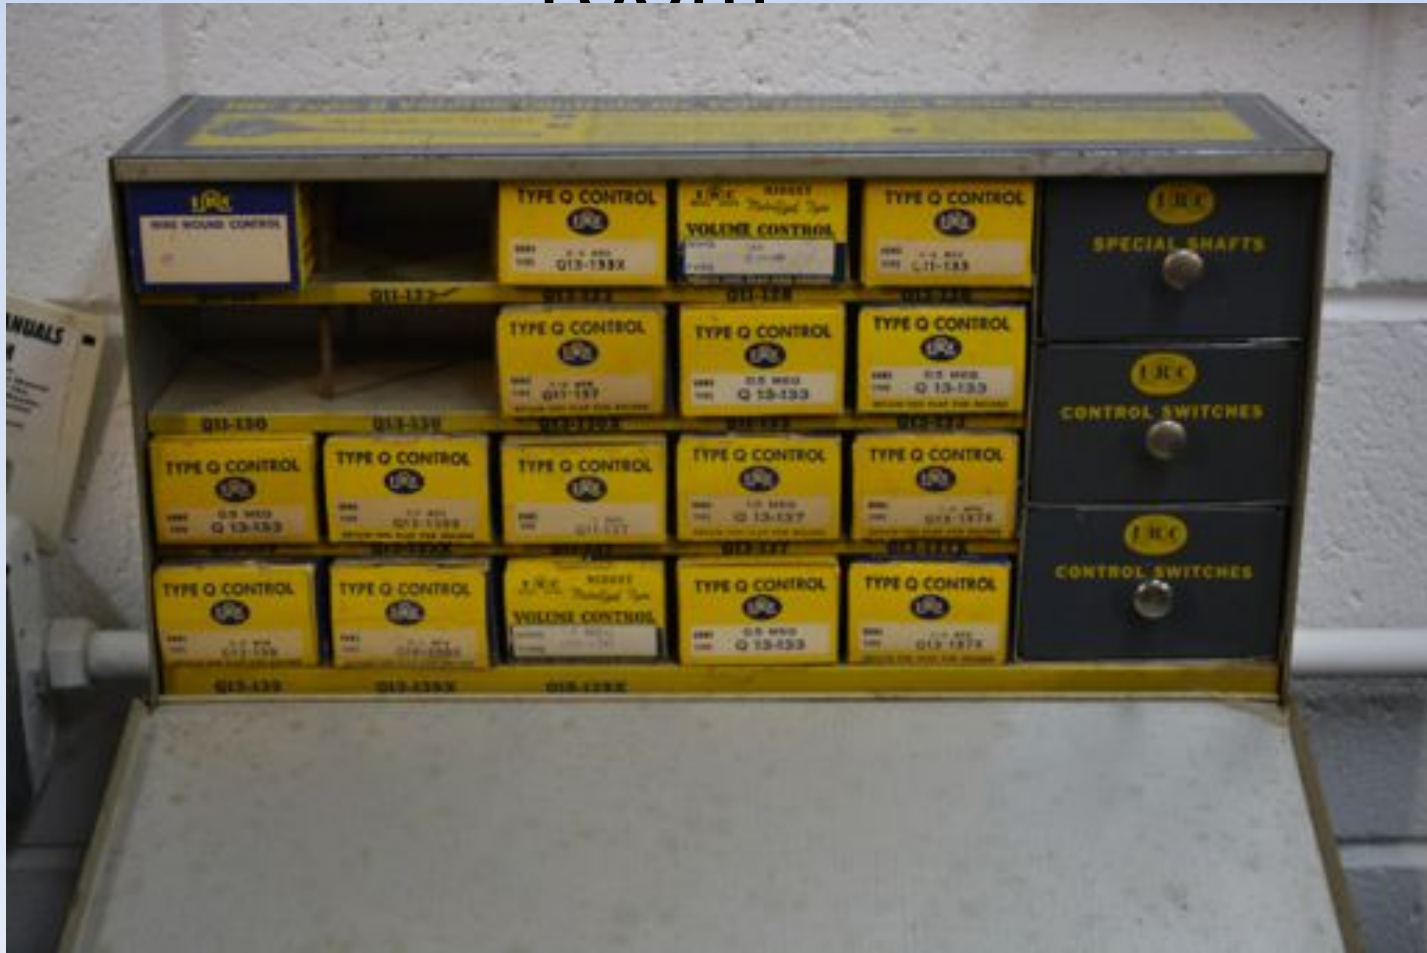
Cabinet Issues

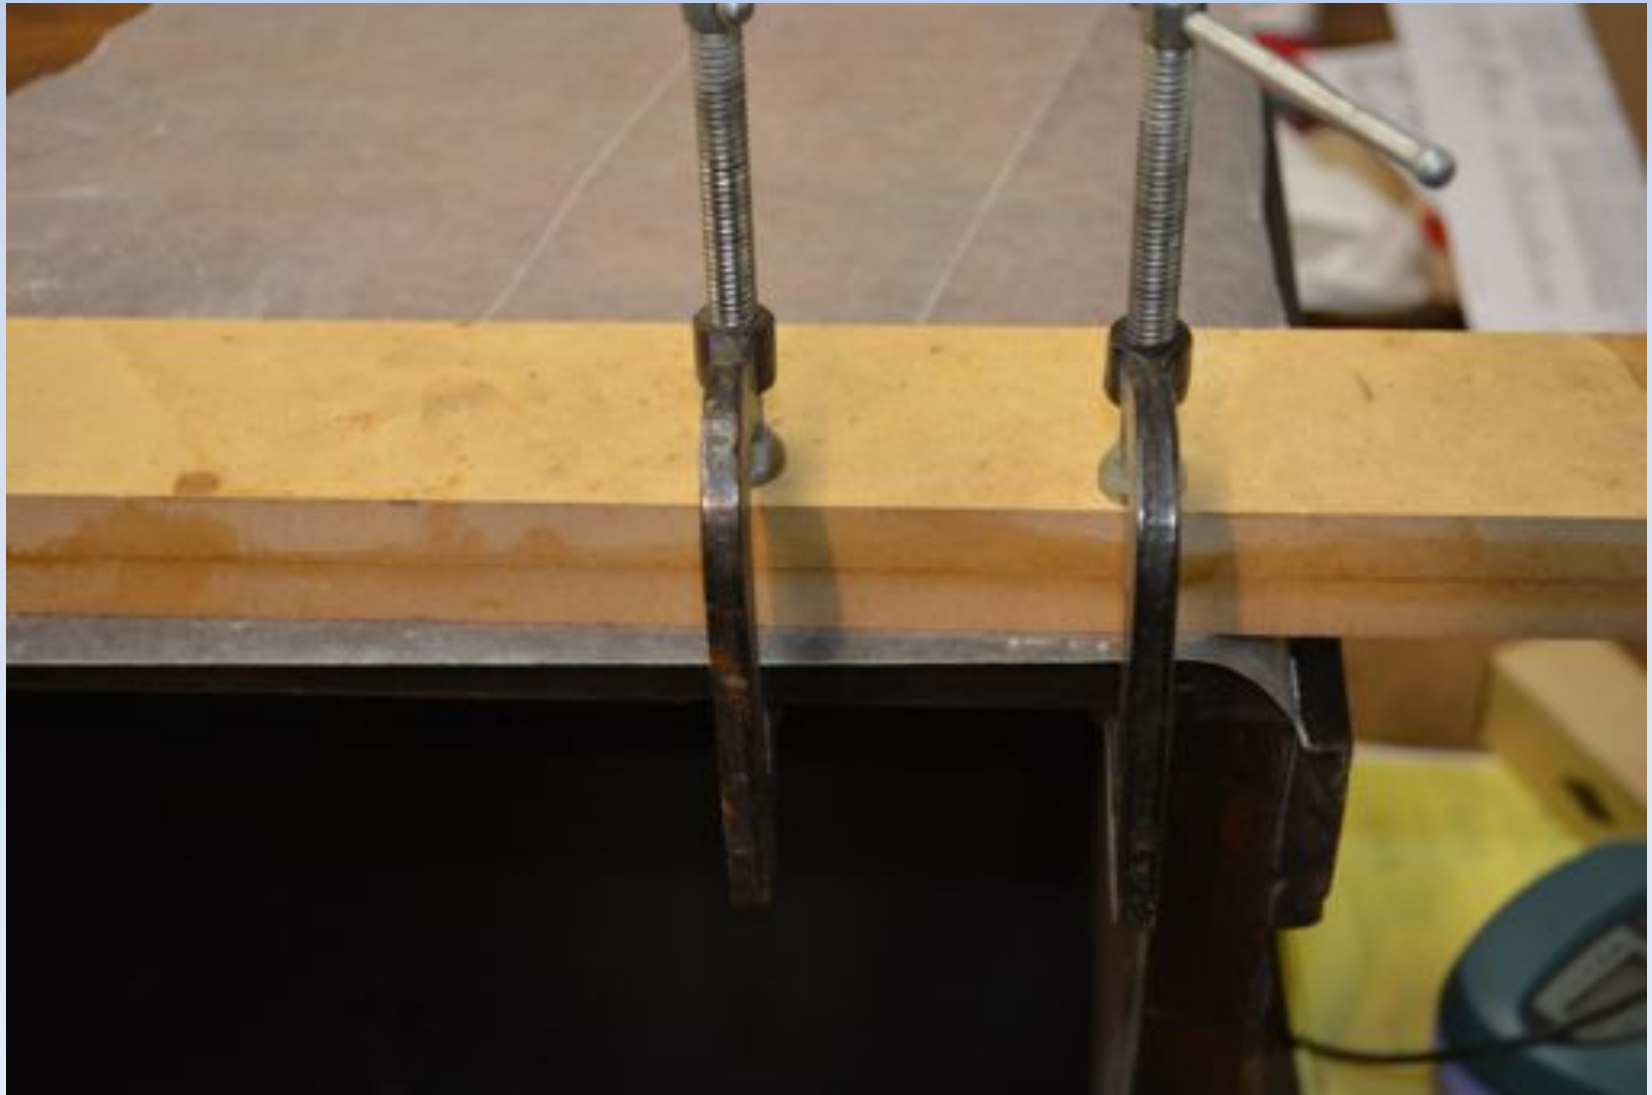
New back cover doesn't fit?

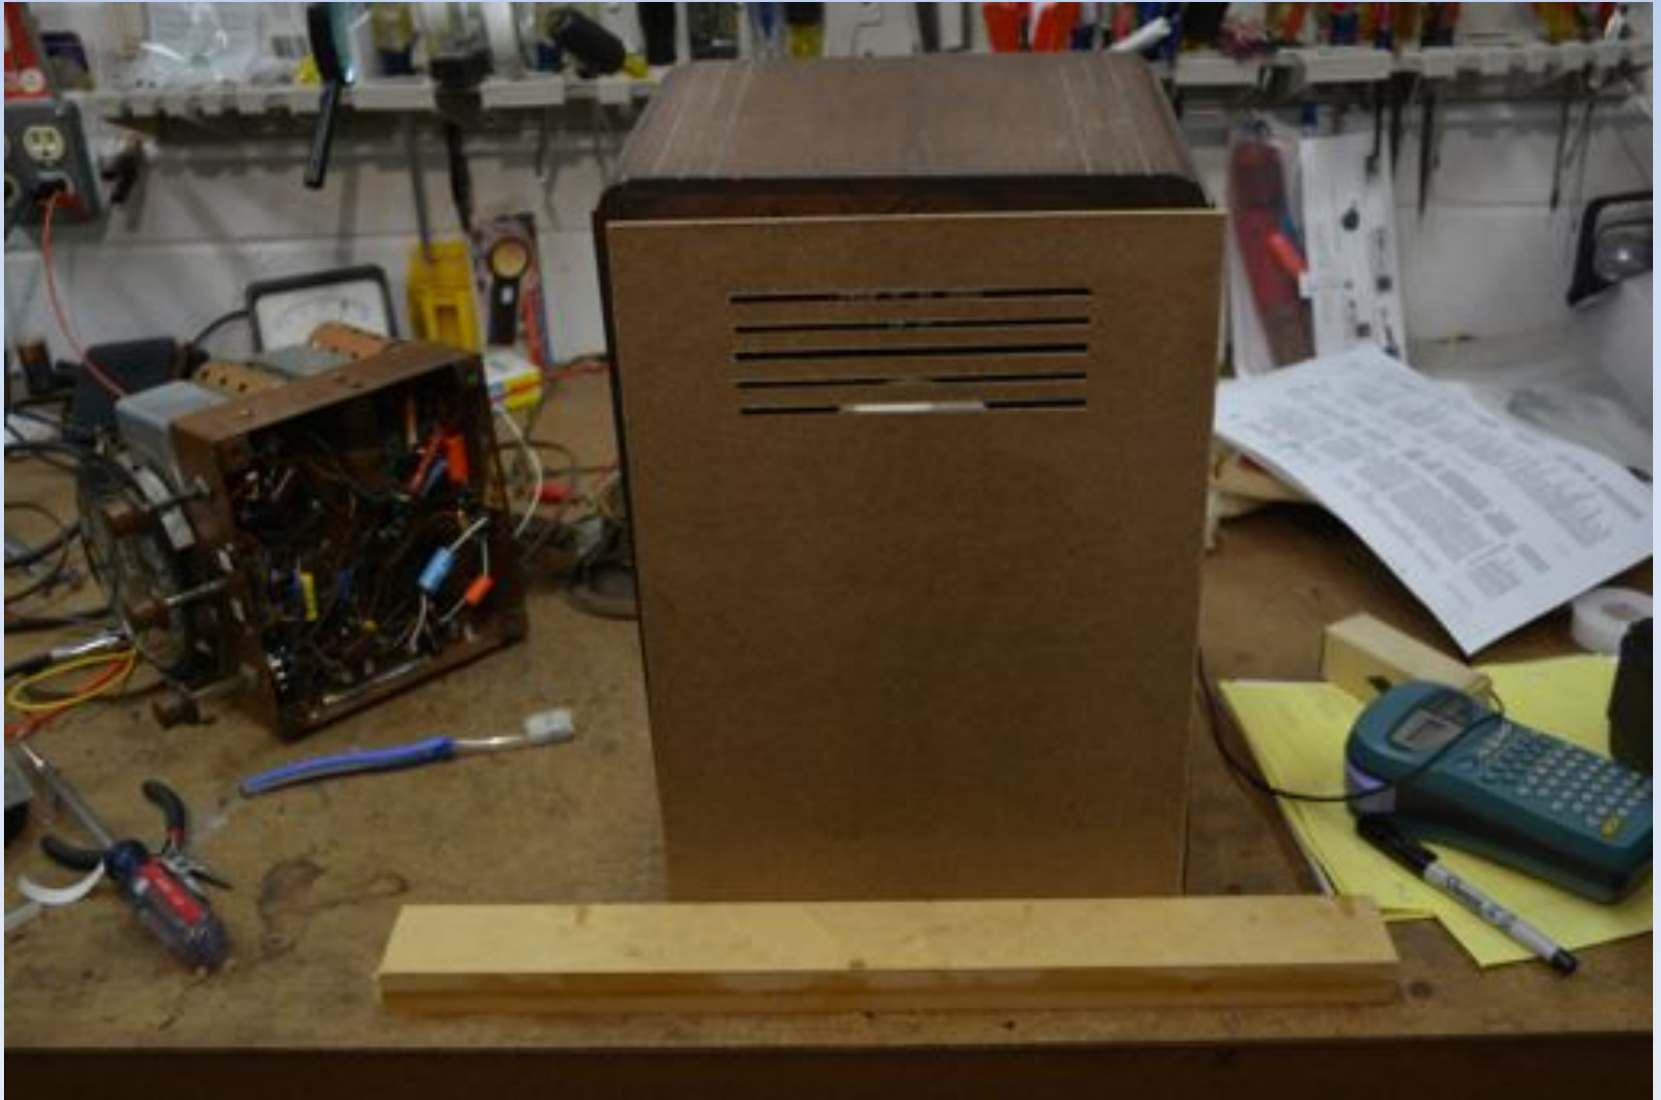
Really a Parallelogram, as made at the factory

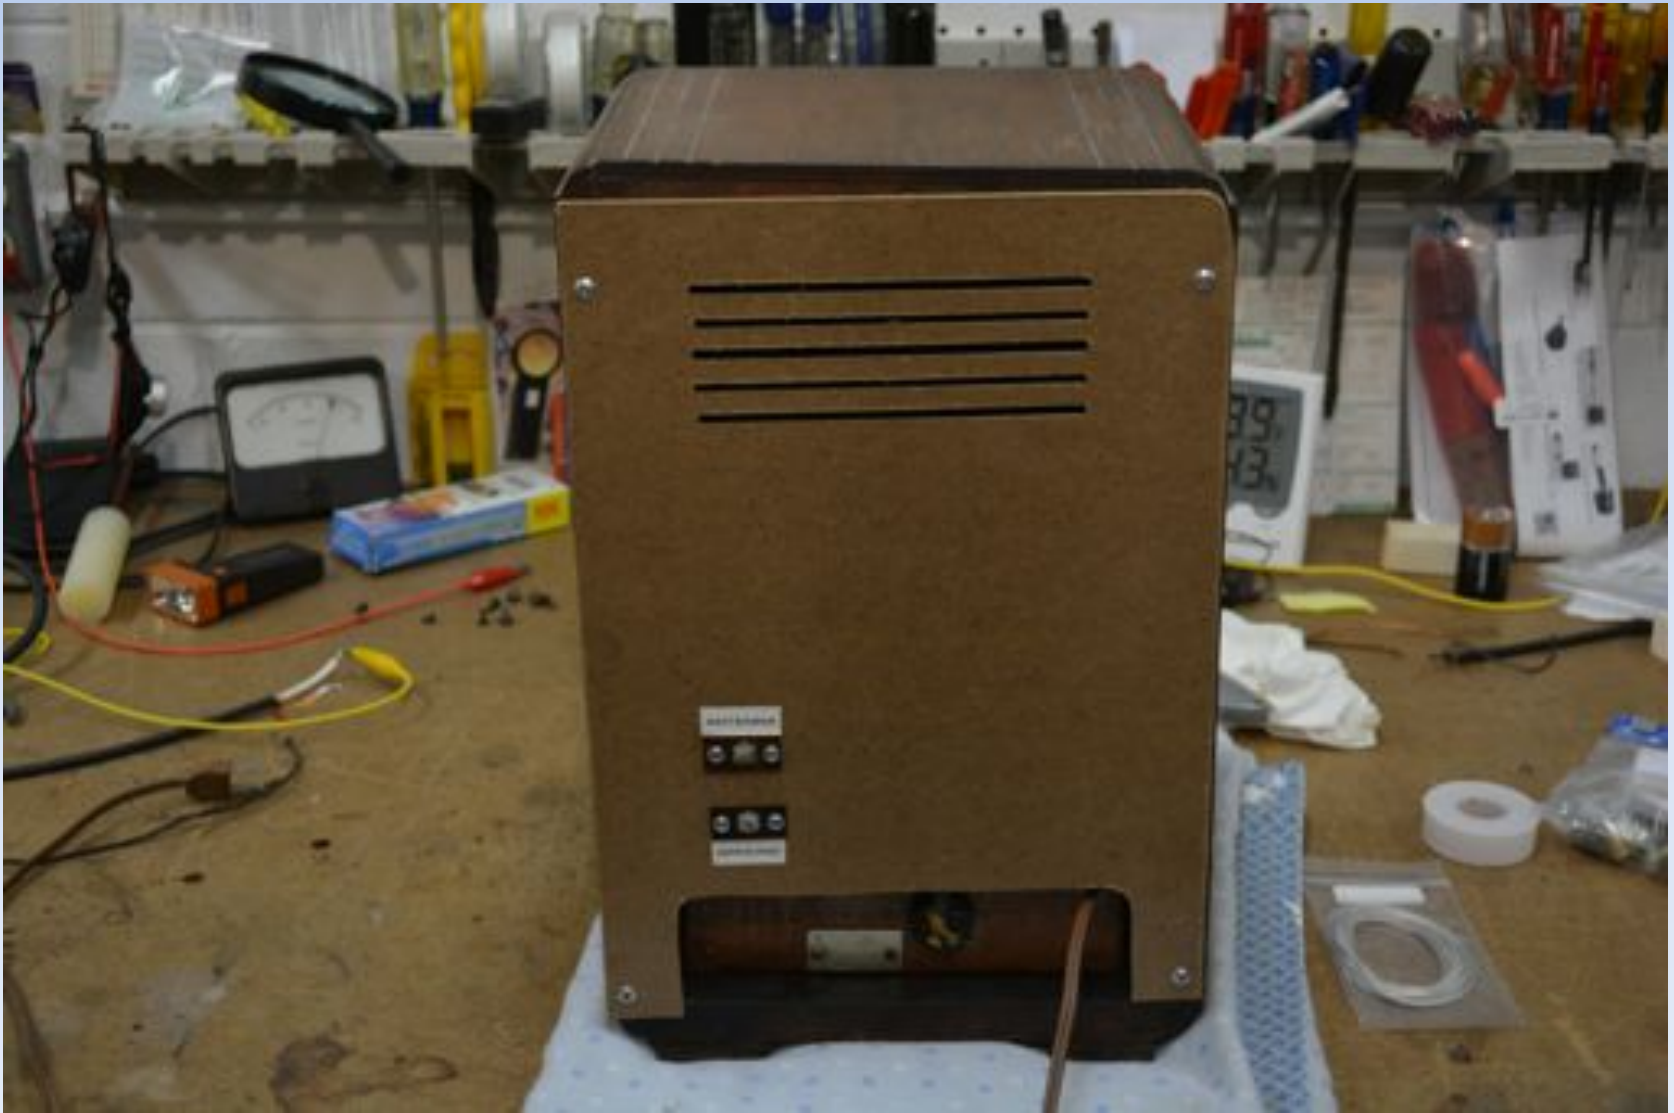
Finished Radio, working 100%
shipped to owner on 10-28-2013
