OLD RADIO REPAIRS

Old Radio Repairs Web Site

A Zenith 5S228, from 1937

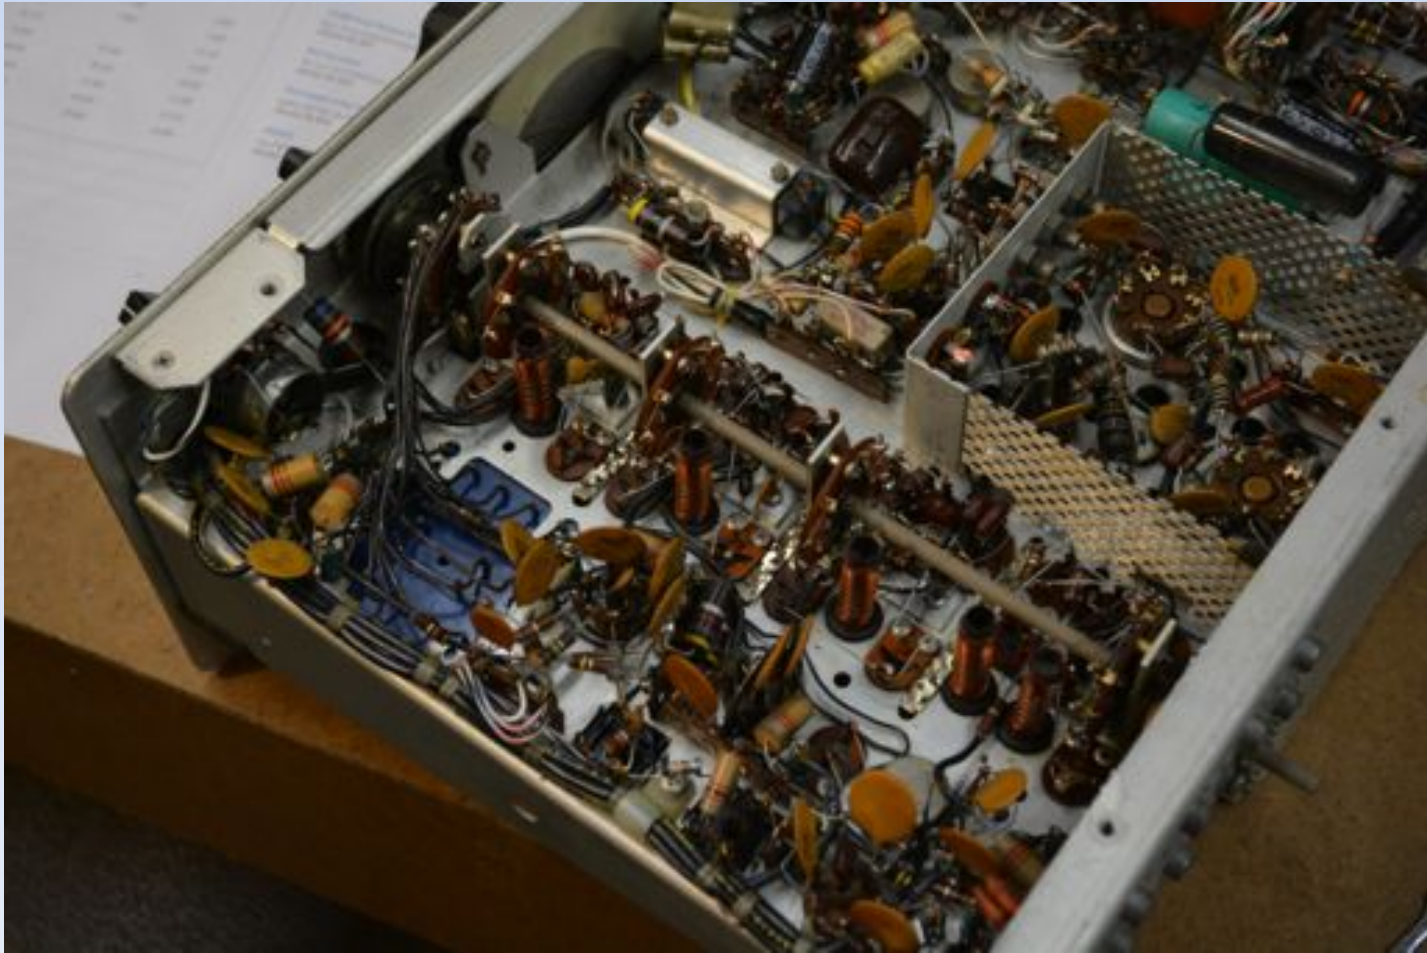
Band Switch Issues
